**Flood Control Project Maintenance
Levee Inspections**

Maintenance Issue Types Only, Levee Inspection Report By Mile - Fall 2018

Reclamation District No. 0341 Sherman Island

Waterway	Bank	Unit Miles	Inspection Start/End	Inspector
Unit No. 01 Threemile Slough	Right	3.36	10/10/2018 10/10/2018	David Julian

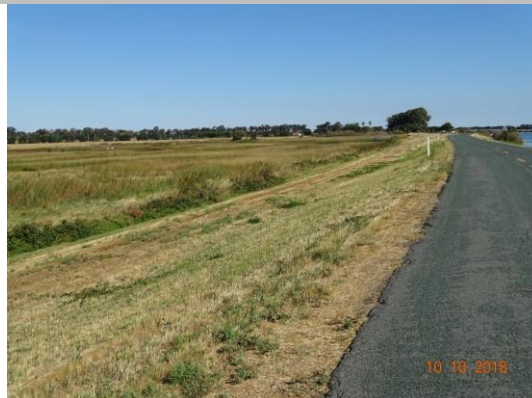
Photo 1 of 1 : FA_2018_RD0341_167_25_20181011_00051.jpg

LM Start	0.00	Rating **	A	Issue No.	25
LM End	0.00	Issue Type +	Ma	Location *	LS
Category	Earthen Levee			GPS Latitude/Longitude	
				Start	End
Item	Vegetation			38.085507°	38.085507°
				-121.686528°	-121.686528°
DWR ID	DWR_RD0341_01_f_2018_25				
Comment Code					
V1 : Control annual grass and weeds on the levee slopes and easements.					
Inspector Comment					
Vegetation is well maintained.

View looking downstream of well maintained vegetation on the land side slope. Vegetation looks like this the whole unit (October 2018).

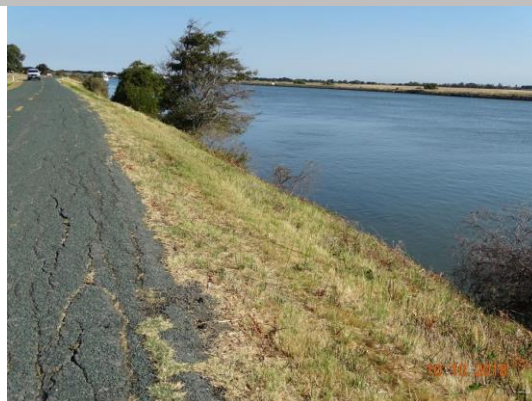
Photo 1 of 1 : FA_2018_RD0341_167_26_20181011_00050.jpg

LM Start	0.00	Rating **	A	Issue No.	26
LM End	0.00	Issue Type +	Ma	Location *	WS
Category	Earthen Levee			GPS Latitude/Longitude	
				Start	End
Item	Vegetation			38.085507 °	38.085507 °
				-121.686528 °	-121.686528 °
DWR ID	DWR_RD0341_01_f_2018_26				
Comment Code					
V1 : Control annual grass and weeds on the levee slopes and easements.					
Inspector Comment					
Vegetation is well maintained.

View looking downstream at well maintained vegetation on the water side slope. Vegetation looks like this for the whole unit (October 2018).

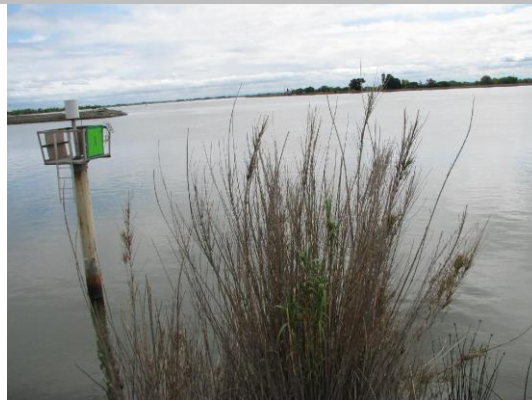
Photo 1 of 3 : UCIP_FA_2018_52252_37640.jpg

Marine station posts in river identified as Station 1 near crossing.

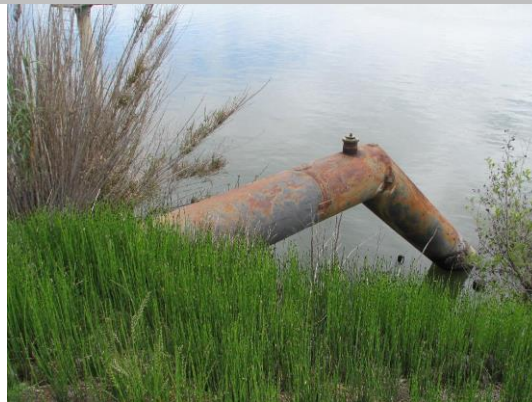
Photo 2 of 3 : UCIP_FA_2018_52252_37644.jpg

Item	DWR UCIP LMA Responsibility		38.085507°	38.085507°								
			-121.686528°	-121.686528°								
DWR ID	24215											
Comment Code												
Inspector Comment												
FS_ID:52252 DS_ID:24215 EP_NO: N/A Repair Type: Non-Urgent Crossing Status: Found UCIP Comments: 05/05/2009 Dense vegetation limits the inspector's visibility to identify signs of pipe failure (leaks) along the slopes. Recommend removing vegetation along pipe alignment to conduct proper inspection of structure and appurtenances. (DWR UCIP - O. Magana) FIELD_STRUCT_DESC: 30-inch steel drainage pipe through the levee, 11.1 feet below the crown. Corrugated metal cutoff wall around pipe at the center of the levee. Siphon breaker is located on both waterside (WS) and landside (LS). Pump is located on the LS approximately 300 feet from LS toe. Pipe is exposed on both levee slopes. Rock revetment present along WS slope. Marine Station number 1 located on WS with an attached small solar panel on top. [Additional Reference(s): DWR Levee Log, 1992. USACE Sacramento O&M Manual Unit No. 101, February 1962, (HLM 0.0). LMA encroachment station (STA) reference based on Map of Evacuation Route, Reclamation District 341 Sherman Island by Wagner Bonsignore Consulting Civil Engineers, A Corporation dated July 2012, STA 175+00]. FS Date: 5/5/2009

View of pipe and siphon breaker located on WS--dense vegetation on slope.

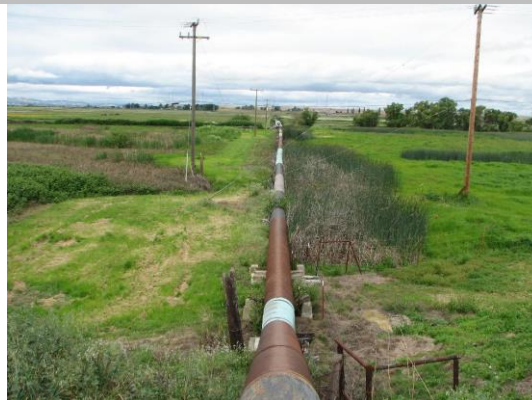
Photo 3 of 3 : UCIP_FA_2018_52252_37642.jpg

Overview of LS slope above ground once it exits levee. Pump is located approximately 300 feet from levee toe.

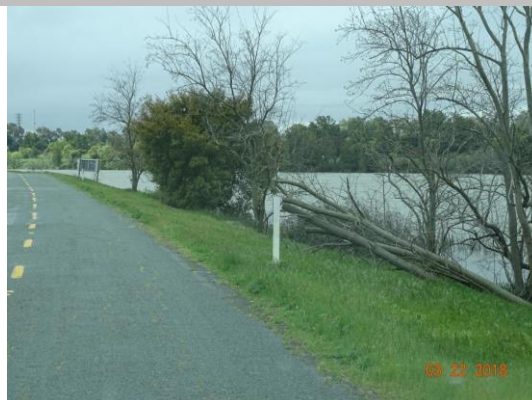
Photo 1 of 1 : FA_2018_RD0341_167_21_20180925_00002.jpg

LM Start	2.19	Rating **	M	Issue No.	21					
LM End	2.19	Issue Type +	Ma	Location *	WS					
Category	Earthen Levee		GPS Latitude/Longitude							
			Start	End						
Item	Encroachments		38.113144 °	38.113144 °						
			-121.687601 °	-121.687601 °						
DWR ID	DWR_RD0341_01_s_2018_21									
Comment Code										
TR : Tree or limb										
Inspector Comment										
Remove fallen tree on waterside slope.

Fallen tree on waterside slope should be removed.

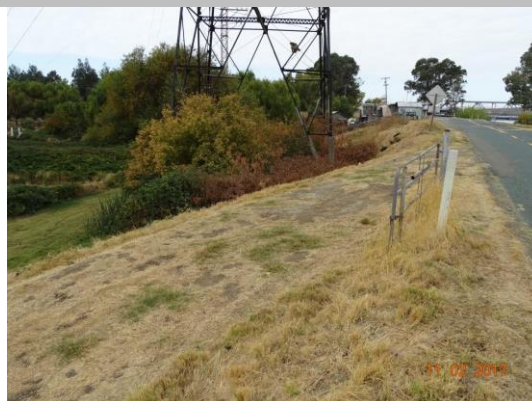
Photo 1 of 1 : FA_2018_RD0341_167_22_20180925_00003.jpg

LM Start	3.21	Rating **	M	Issue No.	22
LM End	3.21	Issue Type +	Ma	Location *	LS
Category	Earthen Levee			GPS Latitude/Longitude	
				Start	End
Item	Vegetation			38.104677 °	38.104677 °
				-121.700030 °	-121.700030 °
DWR ID	DWR_RD0341_01_f_2017_22				
Comment Code					
V2 : Remove the wild growth other than native grasses from the levee slopes.					
Inspector Comment					
Remove vegetation on land side slope.

Remove or thin wild vegetation at base of electrical transmission tower to allow visibility and access to slope and toe.

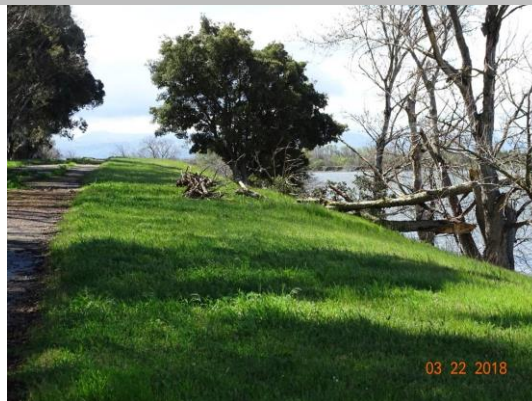
Photo 1 of 1 : FA_2018_RD0341_168_44_20180925_00007.jpg

LM Start	3.48	Rating **	M	Issue No.	44
LM End	3.48	Issue Type +	Ma	Location *	WS
Category	Earthen Levee			GPS Latitude/Longitude	
				Start	End
Item	Encroachments			38.104454 °	38.104454 °
				-121.704275 °	-121.704275 °
DWR ID	DWR_RD0341_02_s_2018_44				
Comment Code					
TR : Tree or limb					
Inspector Comment					
Remove tree limbs from waterside shoulder.

Tree limbs on waterside shoulder should be removed.

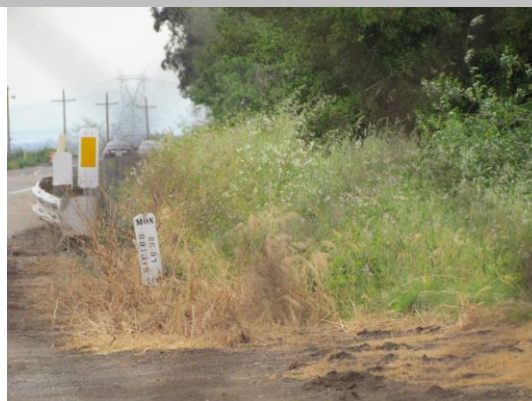
Photo 2 of 2 : FA_2018_RD0341_168_41_20180925_00002.jpg

LM Start	3.94	Rating **	U	Issue No.	41 (cont)	
LM End	6.14	Issue Type +	Ma	Location *	WS	
Category	Earthen Levee			GPS Latitude/Longitude		
				Start		End
Item	Vegetation			38.098158°	38.080223°	
				-121.706320°	-121.730312°	
DWR ID	DWR_RD0341_02_s_2017_41					
Comment Code						
V2 : Remove the wild growth other than native grasses from the levee slopes.						
Inspector Comment						
Remove the unwanted vegetation from the waterside shoulder and slope.

Looking downstream from levee mile 3.94 at tall unwanted weeds and other vegetation on the waterside shoulder and slope.

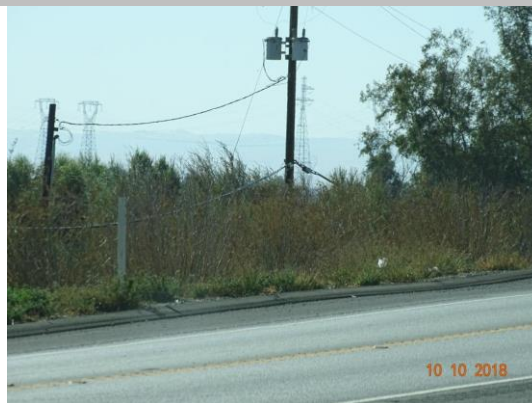
Photo 1 of 2 : FA_2018_RD0341_168_43_20181011_00082.jpg

LM Start	3.97	Rating **	M	Issue No.	43
LM End	6.03	Issue Type +	Ma	Location *	LS
Category	Earthen Levee			GPS Latitude/Longitude	
				Start	End
Item	Vegetation			38.097782 °	38.080143 °
				-121.706262 °	-121.728330 °
DWR ID	DWR_RD0341_02_f_2017_43				
Comment Code					
V2 : Remove the wild growth other than native grasses from the levee slopes.					
Inspector Comment					
Remove the unwanted vegetation from the landside shoulder, slope and toe.

View of vegetation on the land side slope where the levee is on Highway 160 (October 2018).

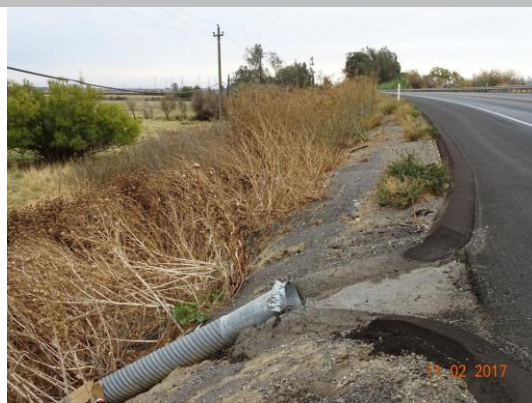
Photo 2 of 2 : FA_2018_RD0341_168_43_20180925_00006.jpg

Remove the unwanted vegetation from the landside shoulder, slope and toe.

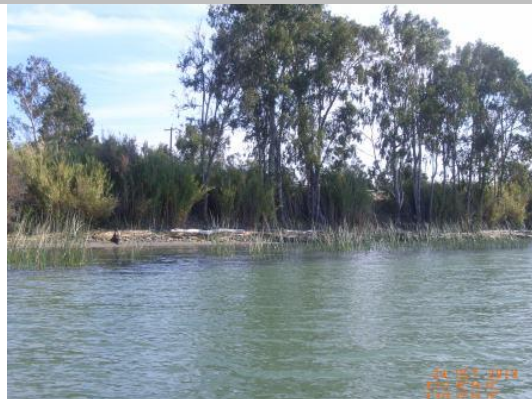
Photo 1 of 1 : FA_2018_RD0341_168_37_20181023_00086.jpg

LM Start	4.00	Rating **	M	Issue No.	37
LM End	4.19	Issue Type +	Ma	Location *	WS
Category	Supplemental			GPS Latitude/Longitude	
				Start	End
Item	2017 USACE Erosion Survey, DRAFT			38.097398 °	38.094590 °
				-121.706321 °	-121.706393 °
DWR ID	DWR_RD0341_02_f_2018_37				
Comment Code					
Inspector Comment					
2017 Site ID: SAC 8.2 L					
Status: Eroding					
2017 Field Notes: Minor new erosion.					
Site History: 2011 - Large new erosion pocket probably hidden by vegetation in the past.

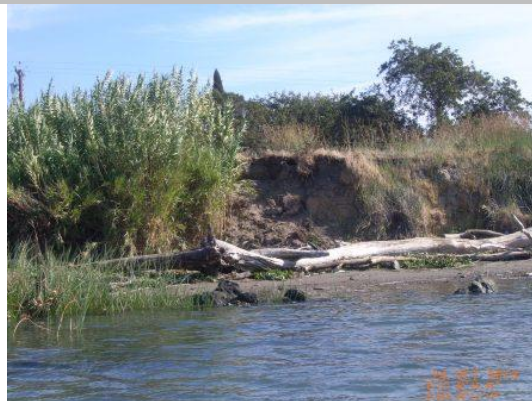
Photo 1 of 1 : FA_2018_RD0341_168_35_20181023_00085.jpg

LM Start	4.47	Rating **	U	Issue No.	35	
LM End	4.70	Issue Type +	Ma	Location *	WS	
Category	Supplemental			GPS Latitude/Longitude		
				Start	End	
Item	2017 USACE Erosion Survey, DRAFT			38.090620 °	38.087425 °	
				-121.706684 °	-121.707639 °	
DWR ID	DWR_RD0341_02_f_2018_35					
Comment Code						
Inspector Comment						
2017 Site ID: SAC 8.0 L						
Status: Critical						
2017 Field Notes: Site extended downstream						
Site History: 1999 - New small slump in eroded bank. 2005 - Reach extended because of vertical bank along the roadway upstream. 2011 - More slumping since last year. 2012 - Site upgraded to critical. Very steep slope which may be effecting the highway on top of the levee. 2015 - New erosion towards the downstream end of site.

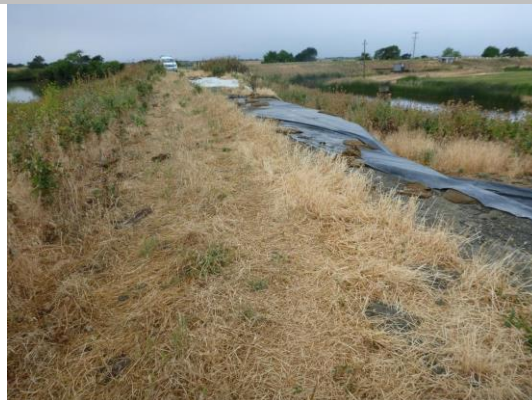
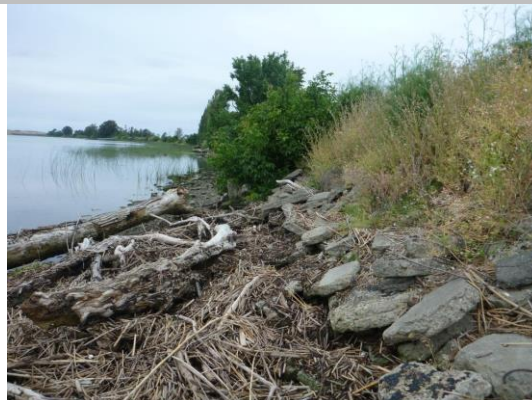
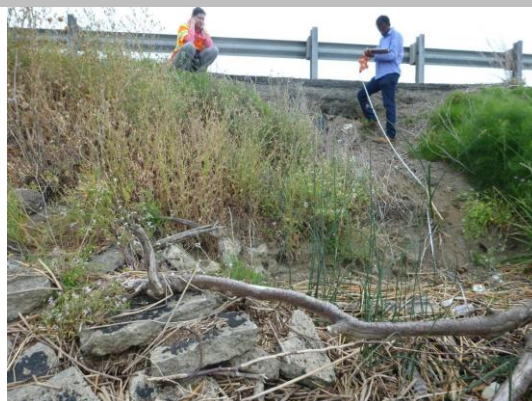
Notes: hwy 160 forms levee crown road, erosion has encroached into paved crown, crown 38' wide. This site is currently under contract for repair under FSRP.

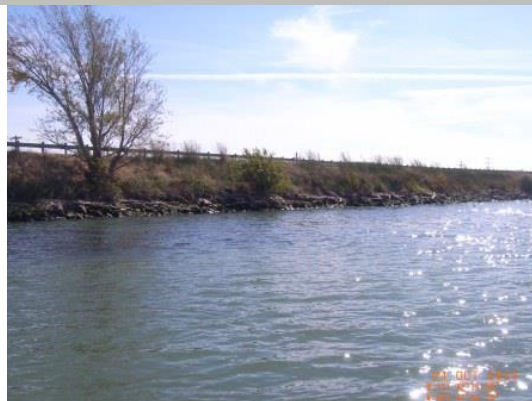
Photo 1 of 1 : FA_2018_RD0341_168_34_20181023_00084.jpg

LM Start	4.76	Rating **	A/W	Issue No.	34
LM End	5.01	Issue Type +	Ma	Location *	WS
Category	Supplemental			GPS Latitude/Longitude	
				Start	End
Item	2017 USACE Erosion Survey, DRAFT			38.086603 °	38.083954 °
				-121.707786 °	-121.710589 °
DWR ID	DWR_RD0341_02_f_2018_34				
Comment Code					
Inspector Comment					
2017 Site ID: SAC 7.9 L					
Status: Critical					
2017 Field Notes: Road base exposed in multiple locations. New tree popout observed.					
Site History: 2011 - Large slump section. 2012 - Site extended downstream, upgraded to critical, severe windwave. Slope is very steep and may be effecting the highway on top of the levee.

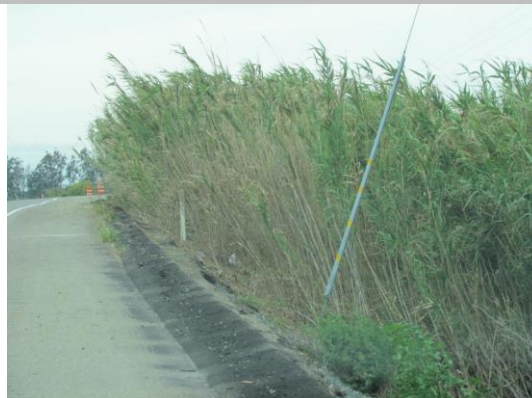
Photo 1 of 1 : FA_2018_RD0341_168_49_20180925_00010.jpg

LM Start	6.03	Rating **	U	Issue No.	49
LM End	6.10	Issue Type +	Ma	Location *	LS
Category	Earthen Levee			GPS Latitude/Longitude	
				Start	End
Item	Vegetation			38.080143 °	38.080125 °
				-121.728332 °	-121.729662 °
DWR ID	DWR_RD0341_02_f_2016_49				
Comment Code					
V2 : Remove the wild growth other than native grasses from the levee slopes.					
Inspector Comment					
Remove the bamboo from the landside levee slope.

RD 341 Landside slope from levee mile 6.03-6.10 tall unwanted growth of Arundo present on the levee section.

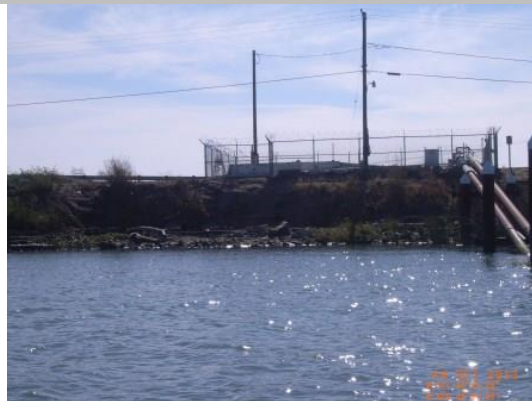
Photo 1 of 1 : FA_2018_RD0341_168_32_20181023_00083.jpg

LM Start	6.03	Rating **	U	Issue No.	32
LM End	6.16	Issue Type +	Ma	Location *	WS
Category	Supplemental			GPS Latitude/Longitude	
				Start	End
Item	2017 USACE Erosion Survey, DRAFT			38.080370 °	38.080526 °
				-121.728341 °	-121.730483 °
DWR ID	DWR_RD0341_02_f_2018_32				
Comment Code					
Inspector Comment					
2017 Site ID: SAC 7.3 L					
Status: Critical					
2017 Field Notes: No observed change..					
Site History: 2011 - Large slump at downstream end. Gully formed from surface runoff from the road. Shallow slumping throughout site.					
2012 - The gully at upstream end has increased in size and site continues to worsen.
